Restoring MG YB 438LRM

Continued...

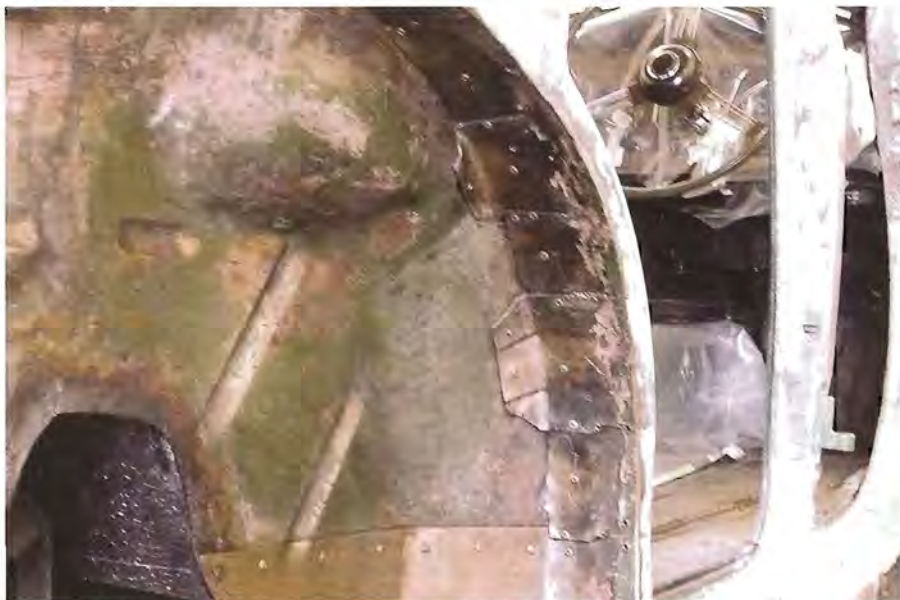
Previous dodgy C Post repairs unearthed.

The door skins were worse than at first thought so their new skinning was extra, the sills have already been mentioned, but an area that surprised me was the offside forward-inner rear wheel arch area; the lower end of the 'C' post. It was very corroded and had been patched by pop-riveting with lots of bits of metal tack-welded in place and given a thick coating of underseal. The rear offside door had often creaked and rattled in its latch on rough roads. Now it was obvious why, the shell was very weak here and required urgent surgery. In the event the whole inner wheel arch area and the lower 'C' post were rebuilt onto the new, stronger sill. The bottom of the 'C' post is also one of the eight body-to-chassis mounting points where it joins the rear seat heel-board. The photos show the rotted out area. The nearside rear 'C' post was nowhere near as bad, but it had obviously been dented in the 1966 accident so required new metal and leading.

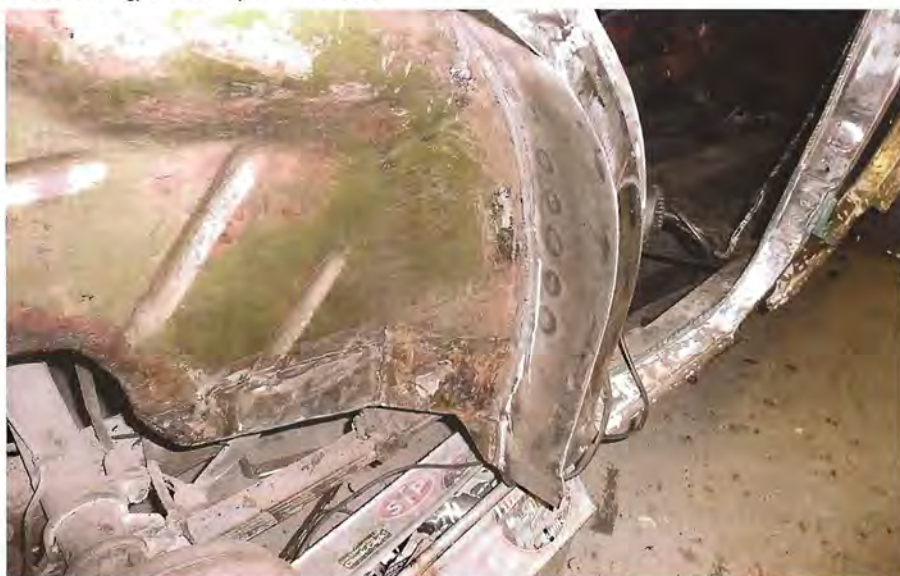
Properly repaired C Post.

YA and YT have 16" narrow-tyred wheels, the YB has wider 15". On the visible areas the panels were found to be spot-welded but only pop-riveted inside the rear wheel arch. This was corrected by B&G whose spot-welding gun had never worked so hard for ages.

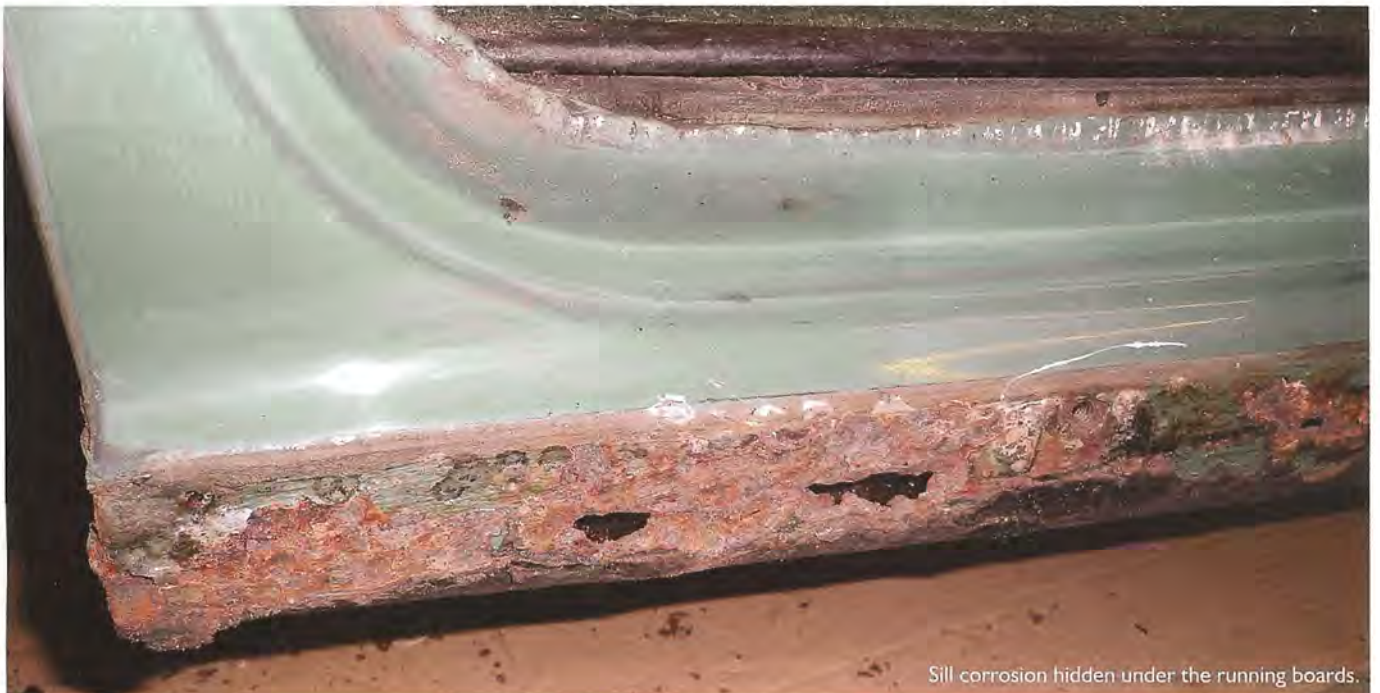
Sill corrosion hidden under the running boards.

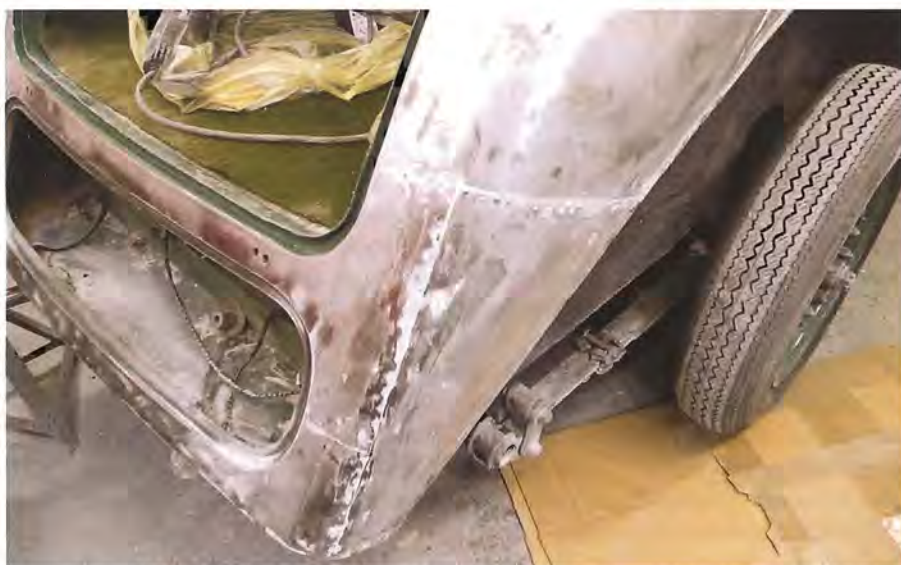
the tax office in Keswick to allocate the 'new' number to my YB. The boot area had obviously been repaired during the car's 1983 respray as once the paint was removed the new panels could be clearly seen. The back end of this model suffers very badly from corrosion if untreated, caused by the liberal salting of our frozen roads back in the 1950-'60s when it got cold in winter and we had real snow. The garage who did the repair work in 1983 used a 'YA' spare wheel compartment panel and lid as they are currently of the YA's narrower dimensions. The YB's is one inch deeper and my cross-ply wheel only just fits; a radial ply would not. The

The rear panels that were fitted in 1983.

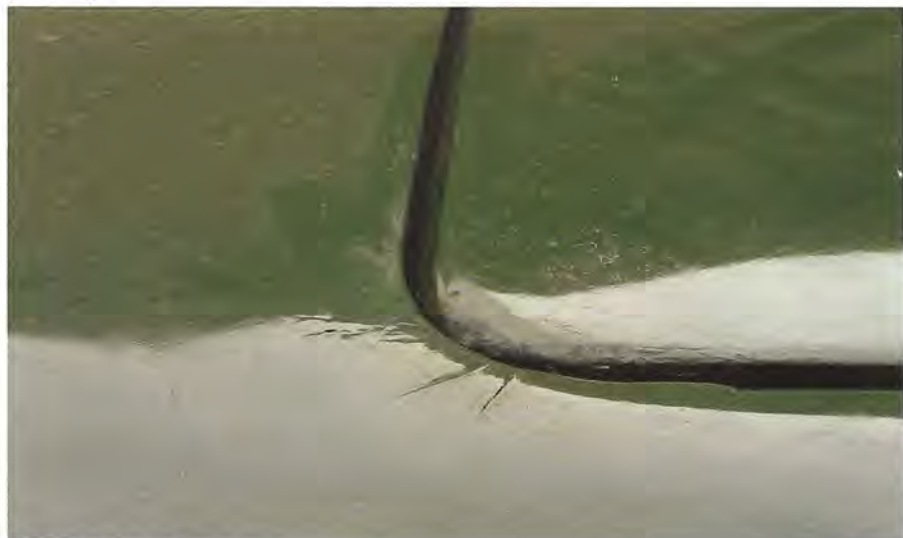
skin profile had been gained by the use of plastic filler, B&G used sheet steel and lead loading. The sunroof aperture in the roof had developed cracks in the offside-rear corner, probably caused by minute flexing of the body shell over its 56-year life. These were welded up and ground flush.

The sunroof cracks.
