LDA 506. AN MG YB RESTORED TO LIFE.

THE MG Y TYPE PEDAL BOX

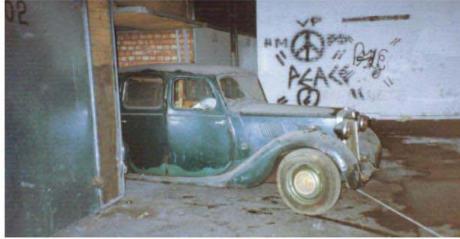
Being dragged out of a lock-up in 1993

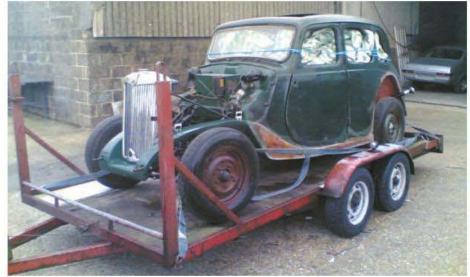
The YB as purchased in 2008 with the engine out

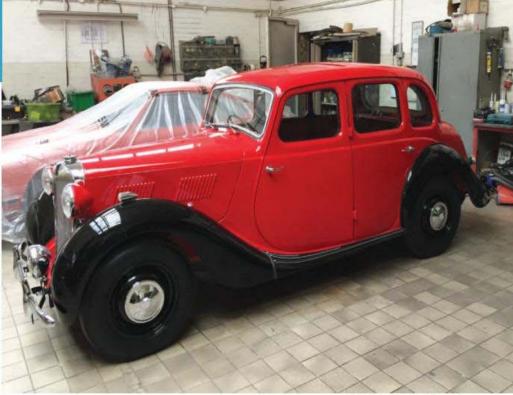
The YB completed in 2019

So now after being out of action since 1973, the car is complete and running, taxed and insured, and registered as an historic vehicle. It seems a shame to have to take it out and get it dirty on the road but that's what this was all about, after all.
