Brian Cox welds in more new metal on his MG Y-Type

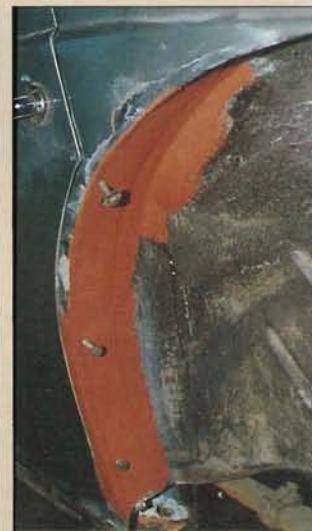
The worst part of the wheel-arch has now been repaired.

Earlier, a new section had been let into the lower trailing edge of the rear wheelarch as part of the repair. This provided a reference point for fitting the final curved section between the bottom of the arch and the back panel.

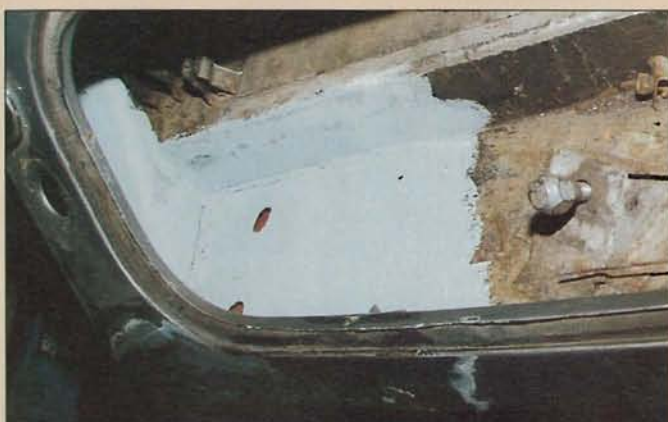
The section of floor replaced in the spare wheel compartment. The body is bolted to the chassis at this point. Note the part-completed work on the panel below the aperture.

Slow but sure progress is being made with the bodywork repairs on the near-side rear corner of my MG Y-Type. The two fixing bolts were removed from the rusty body-to-chassis mounting in the spare wheel compartment, and a wedge was inserted between the chassis and body to lift it slightly so that the corroded metal round the mounting could be removed more easily.

A section of the spare wheel compartment floor was cut out, using an angle grinder, together with part of the narrow section below the spare wheel compartment door.

Originally, the spare wheel compartment floor had been spot-welded to the rear panel, but as I do not have a spot welder, my SIP Migmate 130 Turbo was used to plug weld the two together.

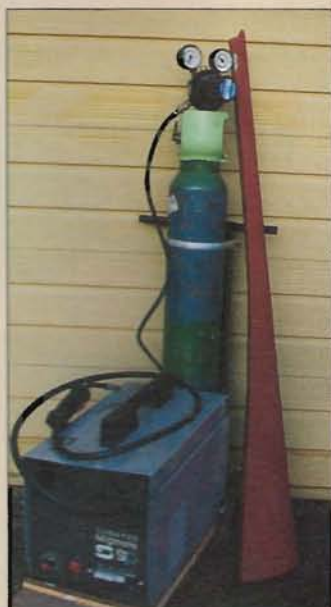
The repaired and painted running board beside the home-made trolley for the welder.

The recently grit-blasted running board, was given a thin layer of Plastic Padding to hide welds and my panel-beating, then dry-sanded to shape. Jeno-lite was used to give the steel a phosphate coating before brushing on two coats of Jeno-lite Double Act primer. This will provide a good key for the primer coats that will be applied when it is a little warmer.
